**United Nations Disaster Assessment & Coordination (UNDAC)**

**COTE D'IVOIRE  
URBAN HAZARDOUS WASTE DUMPING**

**11-19 SEPTEMBER 2006**

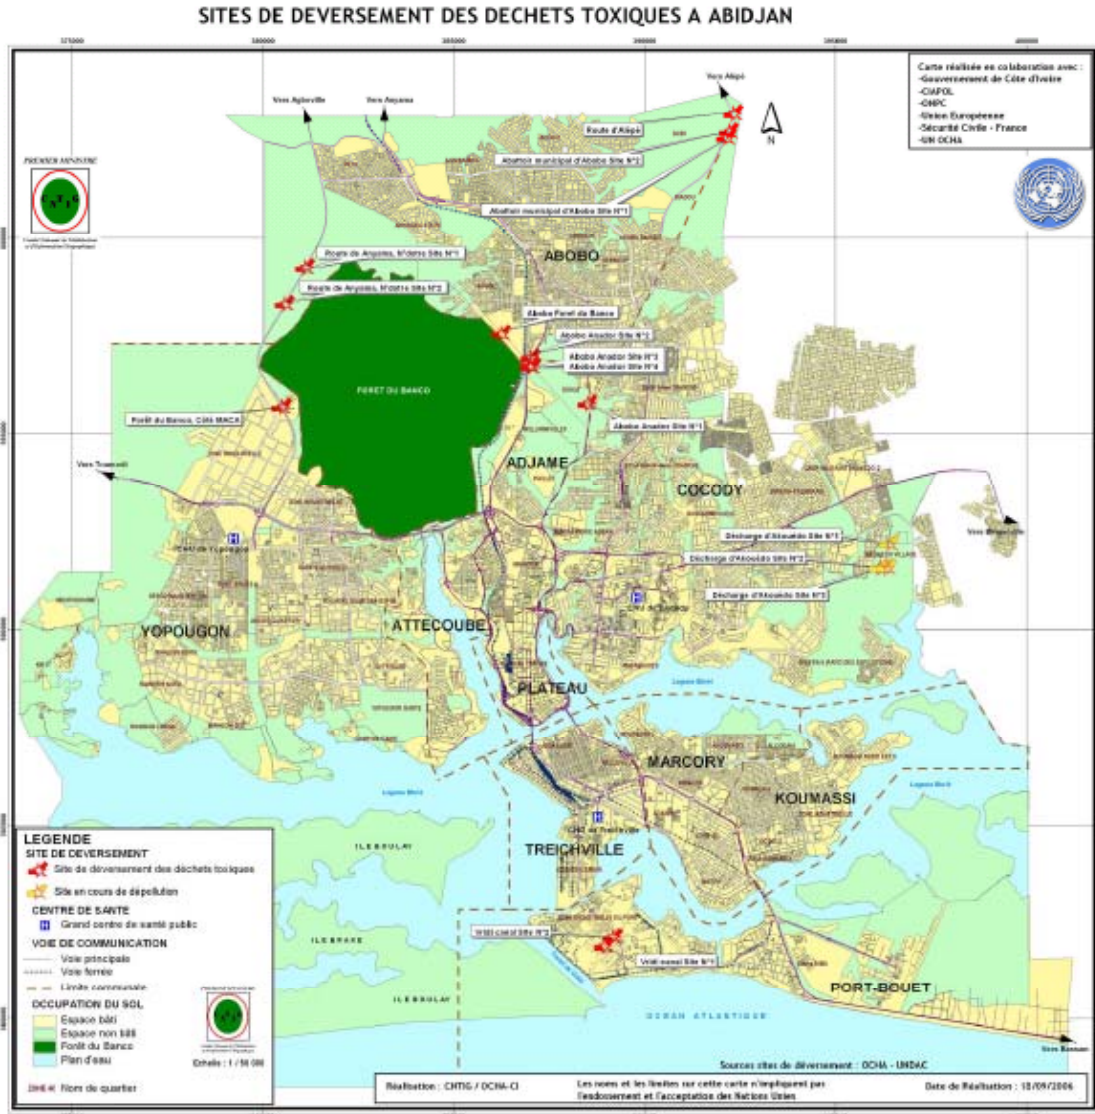
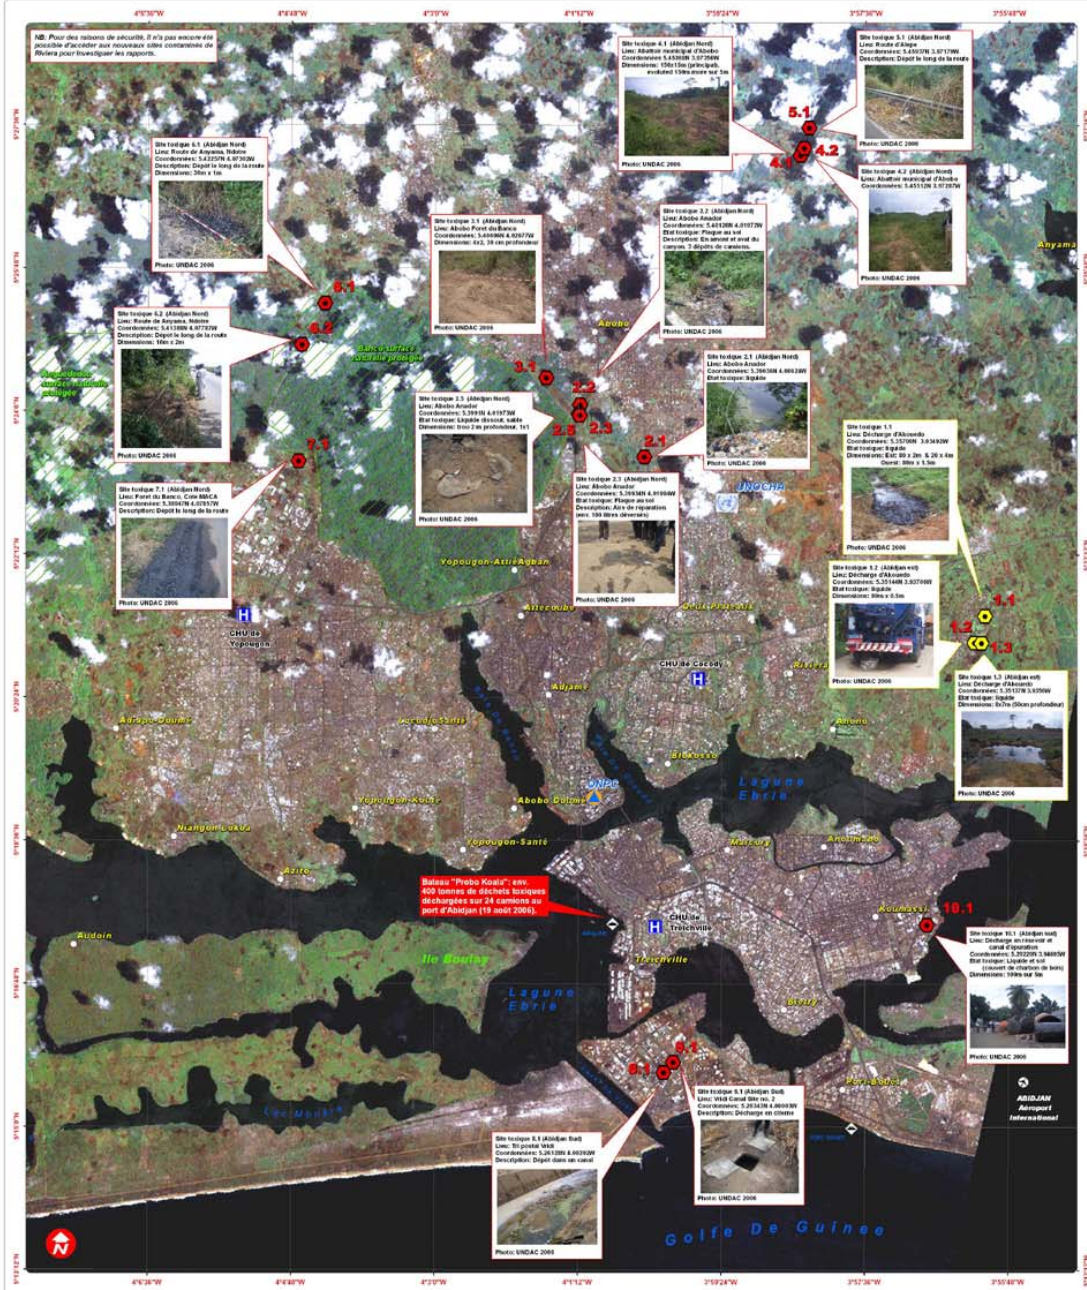
# Abidjan: Carte des sites contaminés

Prepared by CNTIG in collaboration with the government of CDI, CIAPOL, ONPC (Office National de Protection Civile), European Union, French Civil Protection, and OCHA. Site locations and photos by UNDAC.

Emplacements des sites de déchets toxiques documentés par l'équipe de terrain UNDAC du 12 au 17 septembre 2006
